Bavarian Air Crash

Graham Ward

August 9 this year, (2008) marks the 40th anniversary of the crash in Germany of British Eagle Viscount G-ATFN, "City of Truro" in which all 44 passengers and 4 crew perished. Amongst the 44 passengers were 13 from the Merseyside area, and amongst them; a group of 8 young women, all in the prime of their lives, from the Catholic Ramblers Association which still exists and thrives today. In remembrance of this tragic loss, 40 years on, this is the story of those girls, the terrible details of the crash and the catalogue of engineering failures that led to the loss of this aircraft.

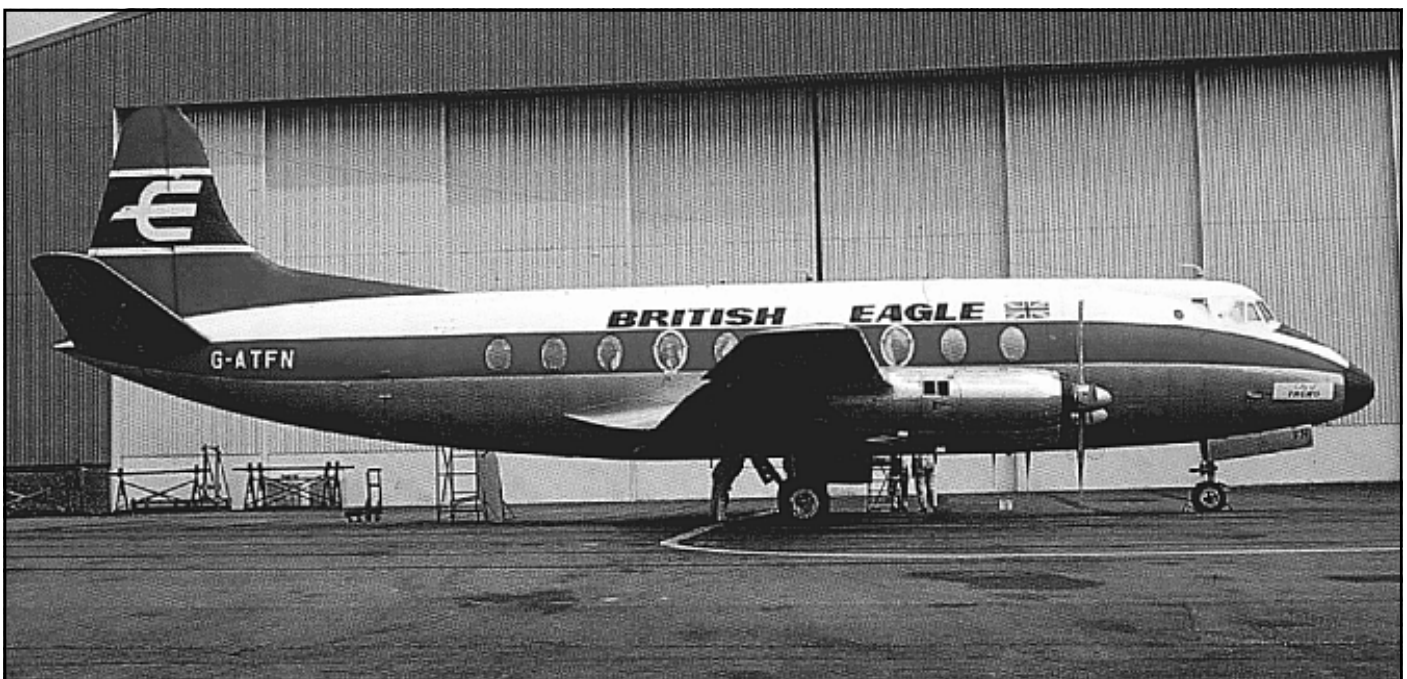
The ill-fated British Eagle Viscount G-ATFN, City of Truro

G-ATFN was a Vickers V.739A Viscount aircraft. It was built in 1958 with the Makers Serial Number (MSN) 394 for the Egyptian airline, Misrair as SU-AKO. (Misrair changed its name to United Arab Airlines on 1 August 1960.) G-ATFN first flew on Tuesday, 15 July 1958 at Hurn, England powered by 4 Rolls-Royce Dart 506 engines. The aircraft was purchased by British Eagle International Airlines Ltd from United Arab Airlines on 3rd September 1965 and took the fleet name "City of Truro". She was leased to Air France between 20 March 1968 and June 1968.
